## The Smart Way to Make Your Tanks Last Longer

24/7 monitored tank-in-tank  
lining to preserve earth for  
future generations

**High Performance Linings, Coatings and Sealings  
for Refineries Tank Farms and Storage Facilities**

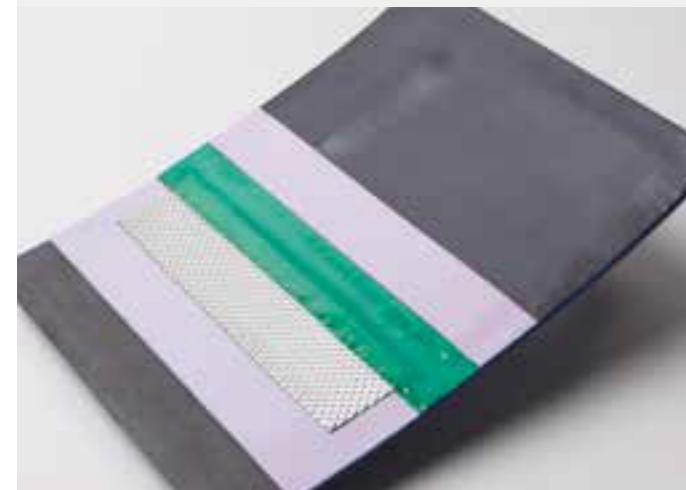
Figure 1. DOPA® layer system application example

The exclusive DOPA® system for converting single to double-walled tanks is the result of our experience, consolidated over more than 30 years of activity. It can be applied to tanks of any non-pressure (atmospheric) size, both above ground and

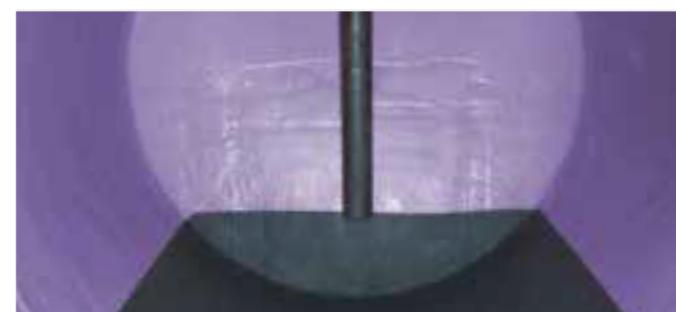
Figure 2. DOPA® system in an underground storage tank  
underground, for the storage of potentially polluting raw, intermediate and finished liquids in the oil and chemical sector.

It creates a cavity in the vertical tanks at the bottom to detect the integrity of the double bottom and prevents pollution from leaks by continuously monitoring the depression. Remote monitoring is carried out on a Wolftank leak detector, which operates autonomously and continuously 24/7 and cannot be deactivated without causing an alarm. This allows the tank to be classified with the highest environmental safety standard (EN 13160 class 1).

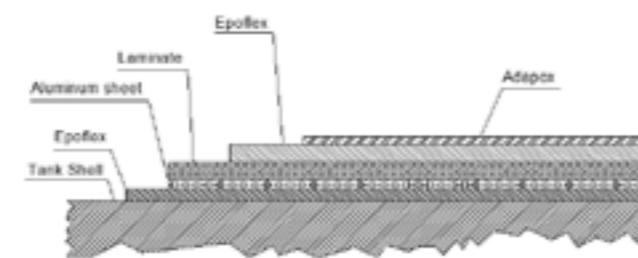
Figure 3. DOPA® 6N layer system application example

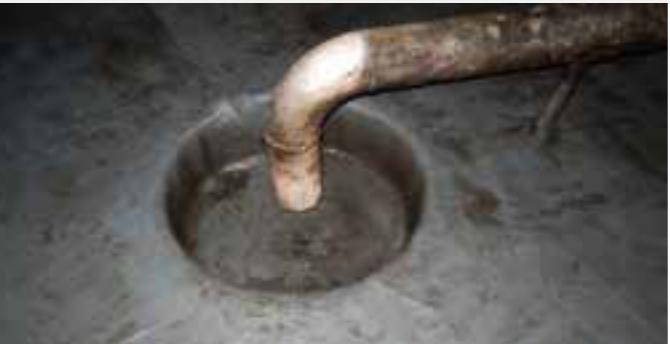
Figure 1. A bulk storage tank, monitored for over 10 years with smart double floor technology (Trecate, Italy).

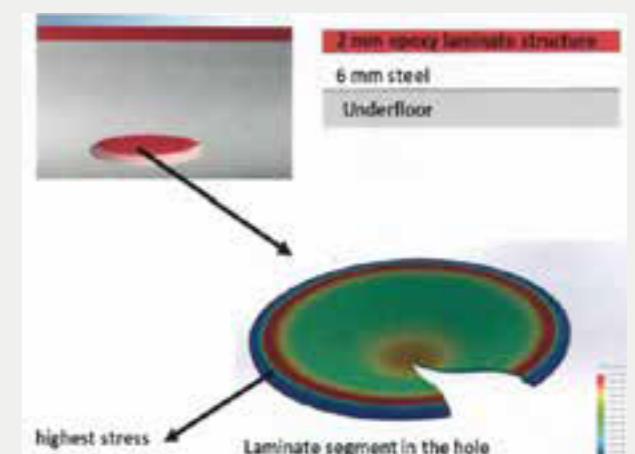
Figure 2. Deformation of laminate due to a hole in the steel as a result of underfloor corrosion.

Figures 2 and 3 show the stress the laminate is exposed to when the hydrostatic pressure of the storage liquid is affected by a hole in the steel below, and for different diameters of such a hole. It can be seen that a laminate thickness of 4 mm can easily resist right up to a hole of 230 mm, and in the presence of such a hole, the mechanical load the laminate is exposed to corresponds only to 50% of the tensile strength of the laminate itself.

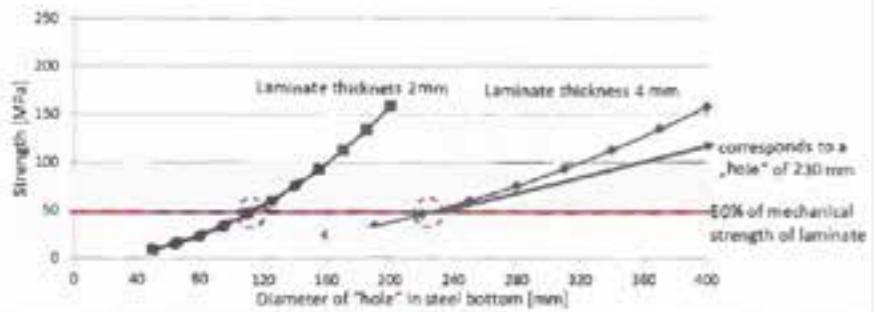
Figure 3. Diameter of a hole in steel, which laminate can resist.

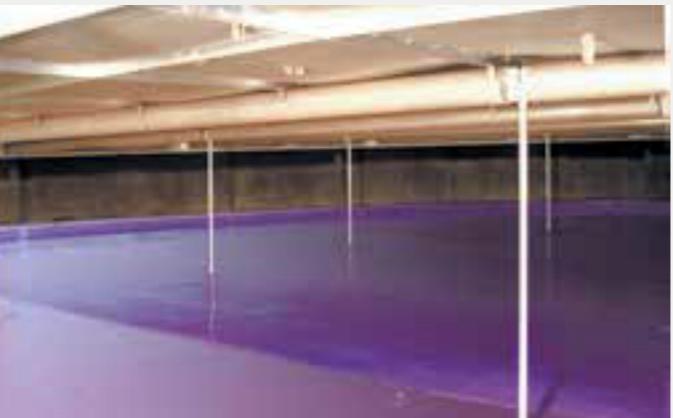
Figure 4. Double floor technology based on epoxy coating

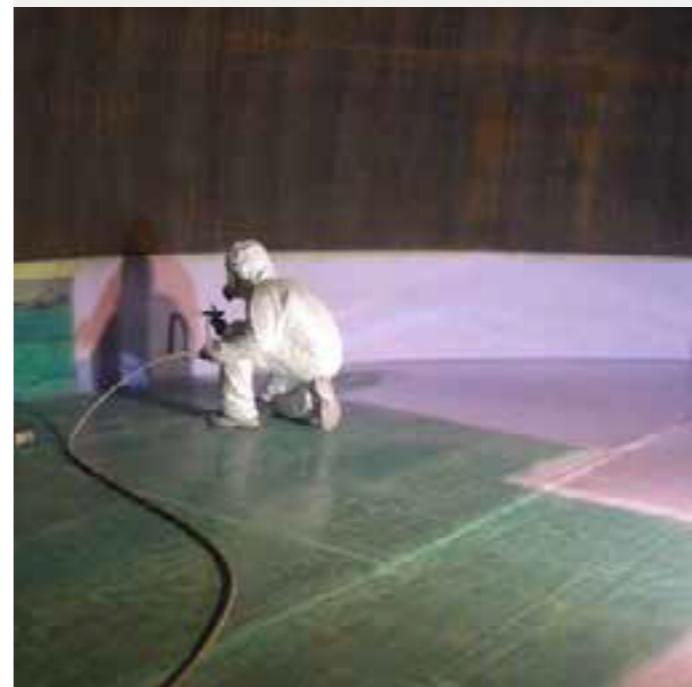
Figure 5. Application of smart double floor technology

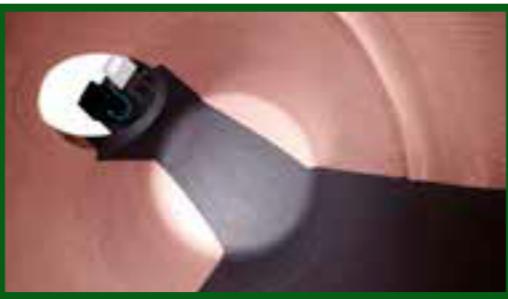
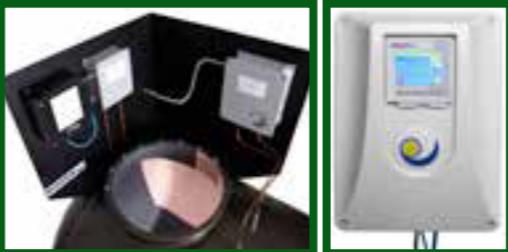
The DOPA® system is a solution technically equivalent to replacing a single wall tank with a double wall tank, allowing the system to achieve the highest standards of environmental safety (EN 13160 class 1) and provide continuous remote 24/7 monitoring with an intelligent and automated leak detector.

The DOPA® leak detection system is automated and tamper-resistant, meaning that an alarm sounds when one of the two walls is compromised or the device is tampered with or shut down.

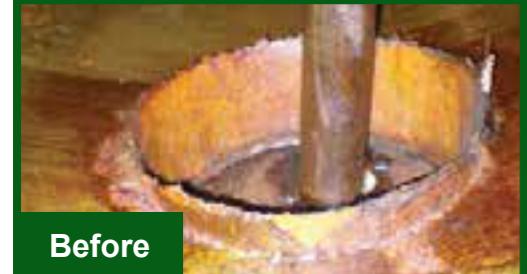
Before

Storage tanks for potentially polluting liquids require a high initial investment and during their life cycle they are exposed to severe conditions, such as weathering and highly aggressive chemicals. Proper plant operation requires periodic maintenance to monitor corrosion trends and prevent product loss and resulting environmental pollution, thereby preserving the value of the investment.

Aggressive chemicals, such as sulfur concentrate on the bottom of the tank, making it the most vulnerable due to fatigue, stress corrosion, static breakage, chemical aggression and similar situations that can lead to the decay of a storage facility of potentially polluting liquids.

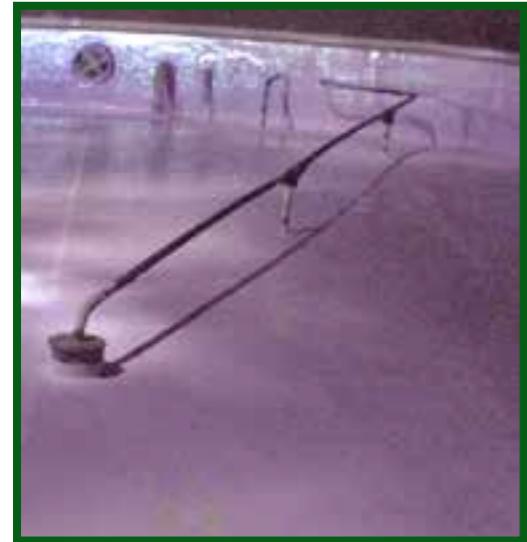
EEMUA 159, the European standard for maintenance of flat bottom tanks specifies the criteria for the determination of the lifetime of storage tanks. The rejection limit for the bottom is defined as following: „Rejection limits for the thickness of the tank bottom can only be prescribed in relation to the probability of leakage due to corrosion...“

Based on this statement the standard recommends the application of laminates for tank bottoms with an advanced corrosion. They are completely resistant against any chemical attack. Long term experience for more than 20 years as well as FEM simulations have shown that laminates can eliminate any risk of leaking even in case the a steel floor perforated by corrosion.

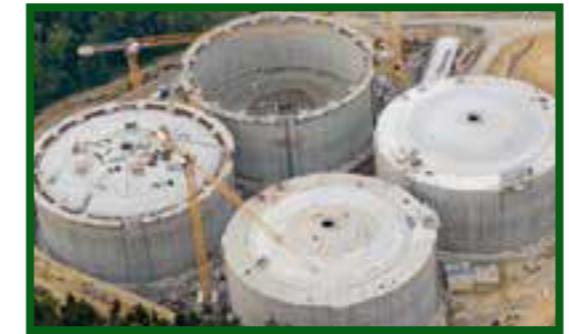
The system consist of a base layer which creates the gas tightness of the concrete surface preventing infiltrations and structural degradations of the entire concrete structure. Subsequently, an inner lining system is applied with the DOPA® technology.

The interstice between the inner lining and the outer wall, like for conventional DOPA® installations, is created in conformity to EN 13160 and can be continuous vacuum.

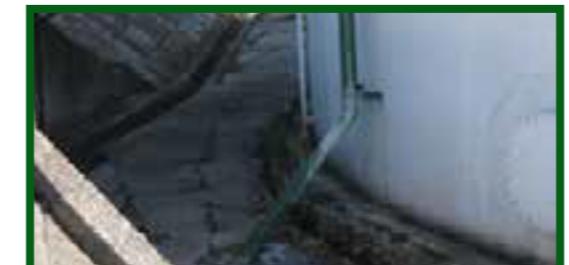
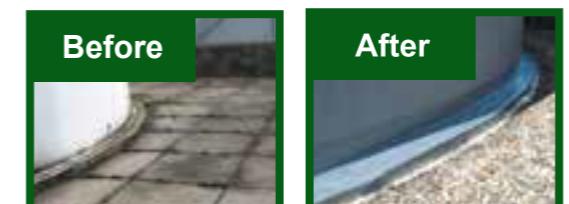
These areas are usually exposed to weathering and tanks can be subject to damage or decay, resulting in leaks and groundwater contamination. The products we use to solve these problems are the result of many years of research in the field of composite materials, specially designed for the type of product stored and the weather conditions such as exposure to UV radiation.

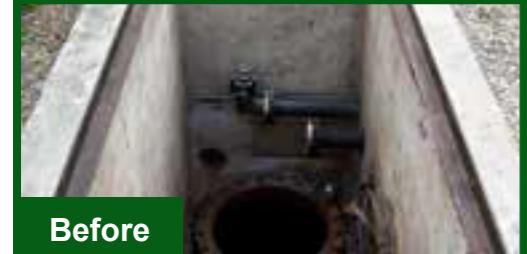
Before

Sumps are a critical element of all storage facilities for potential contaminating liquids. This is especially important during the product transfer of the liquids, where the liquids can get in contact with the walls of the sump. If the sump walls are not liquid proof, the problem can now be solved with our sump refurbishing system.

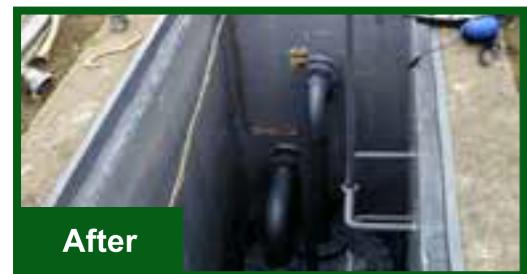
After

Using specifically designed and certified composite materials, the sump can become a liquid-tight container to protect the soil from leaks. This also reinforces the sump's structure and protects the metal parts inside from corrosion.

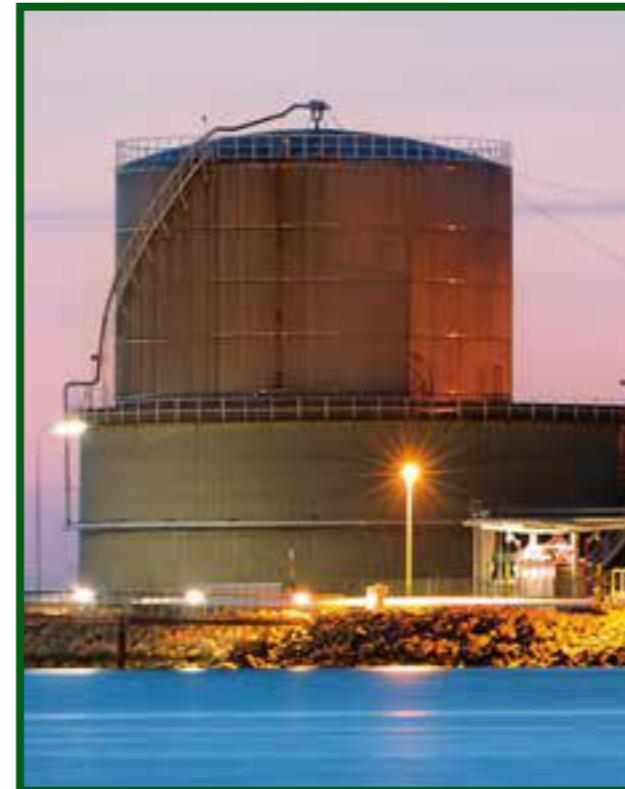
### Structures which are immersed in water

It is a big difference if the structure is built in salt, brackish or fresh water and also the oxygen quantity which contains the water is a really important factor how fast and aggressive the corrosion is going to proceed.

We define three different zones for structures built in water:

- The underwater zone, which is constantly immersed in or near water
- The intermediate zone, in which the water level changes due to natural or artificial effects. Thus giving rise to corrosion due to the combined impact of water and atmosphere
- The splash zone, is the area which is wetted by waves and spray action. It can cause exceptional high corrosion stresses, especially with sea water.

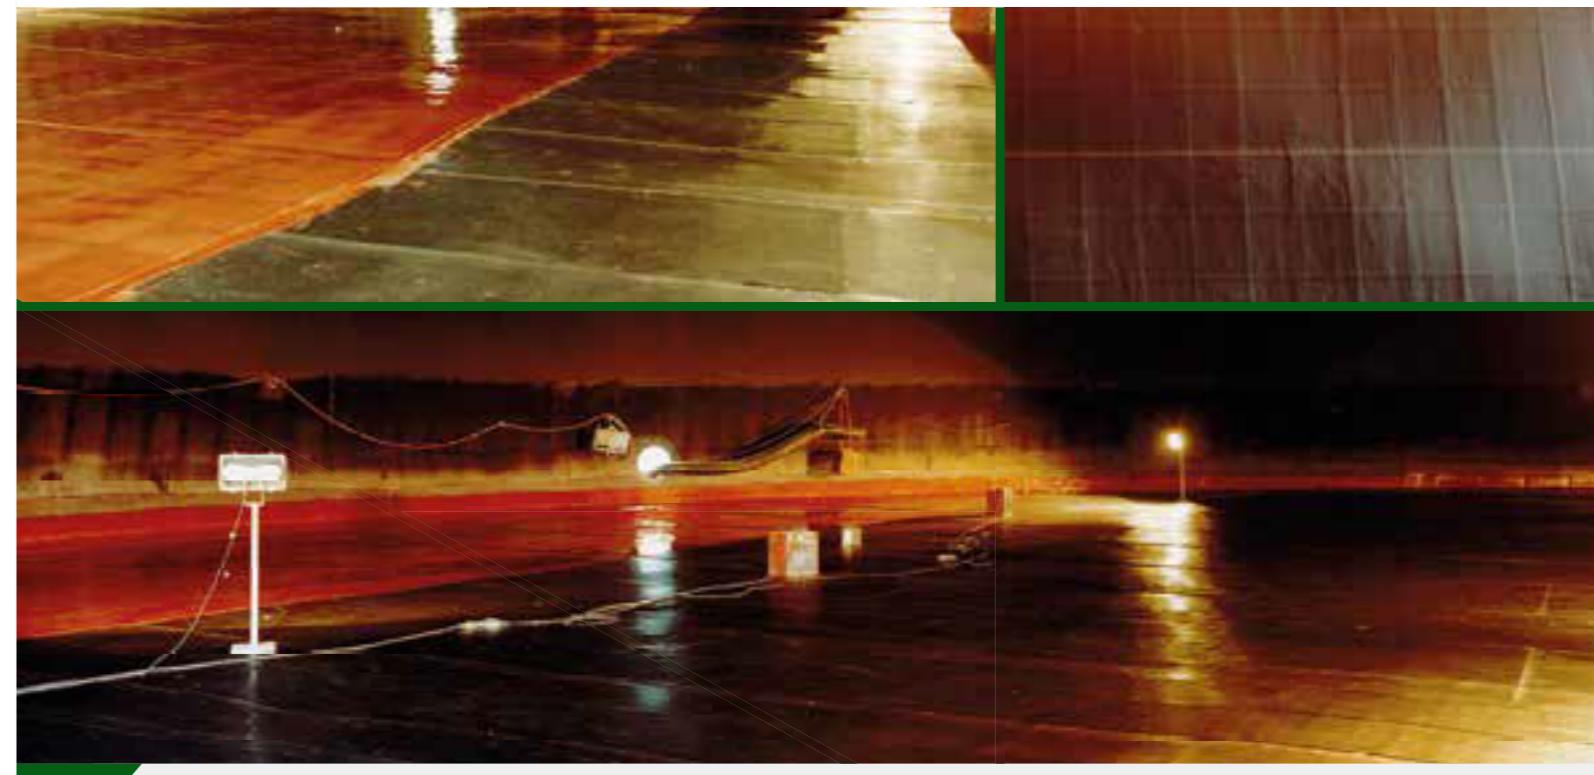
## Case Study 1: 1995 Switzerland

The floor of the storage tank has been lined with DOPA® in 1995.

Tank still in operation with continuous 24/7 floor tightness vacuum monitoring and since 22 years no maintenance cost.

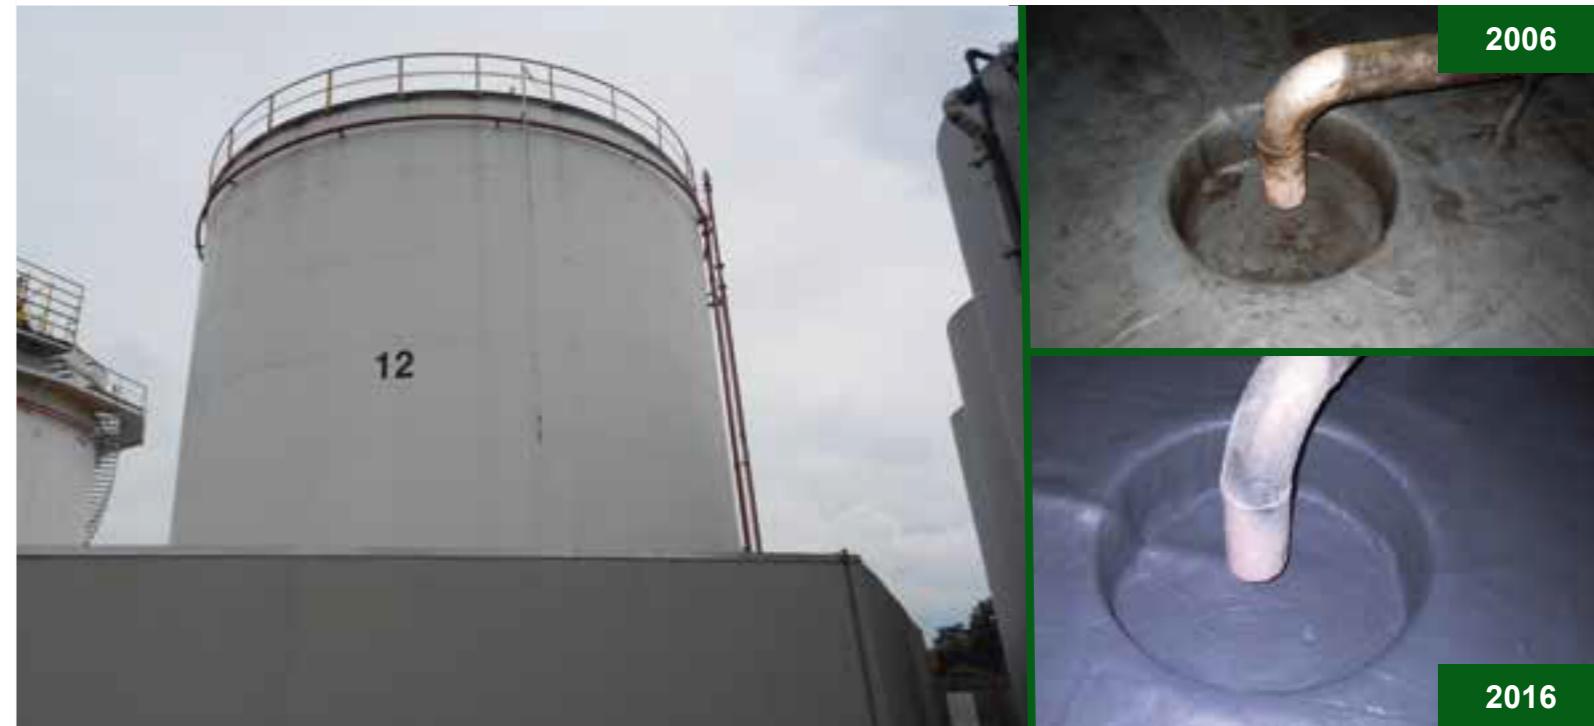
## Case Study 2: 2006 Italy

The floor of this tank has been lined and transformed to double wall and has been opened after 10 years of continuous operation of legal inspection.

No aging or damages have been found despite no maintenance costs after 10 years of operation.

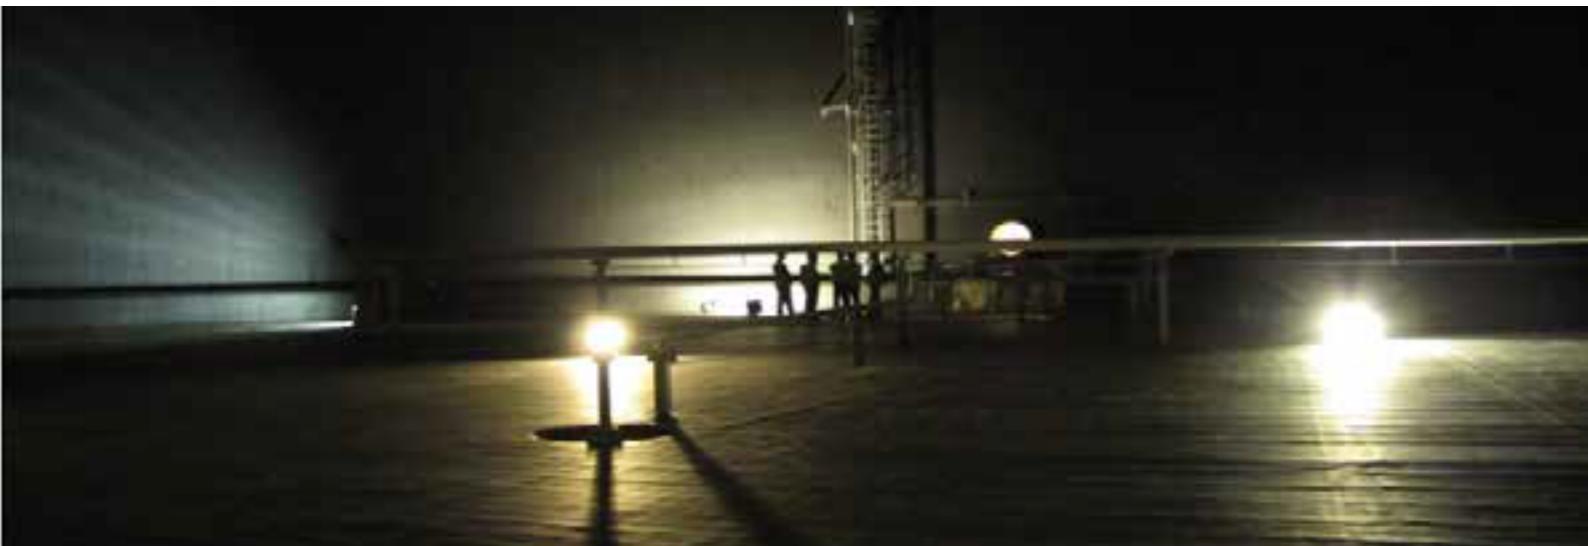
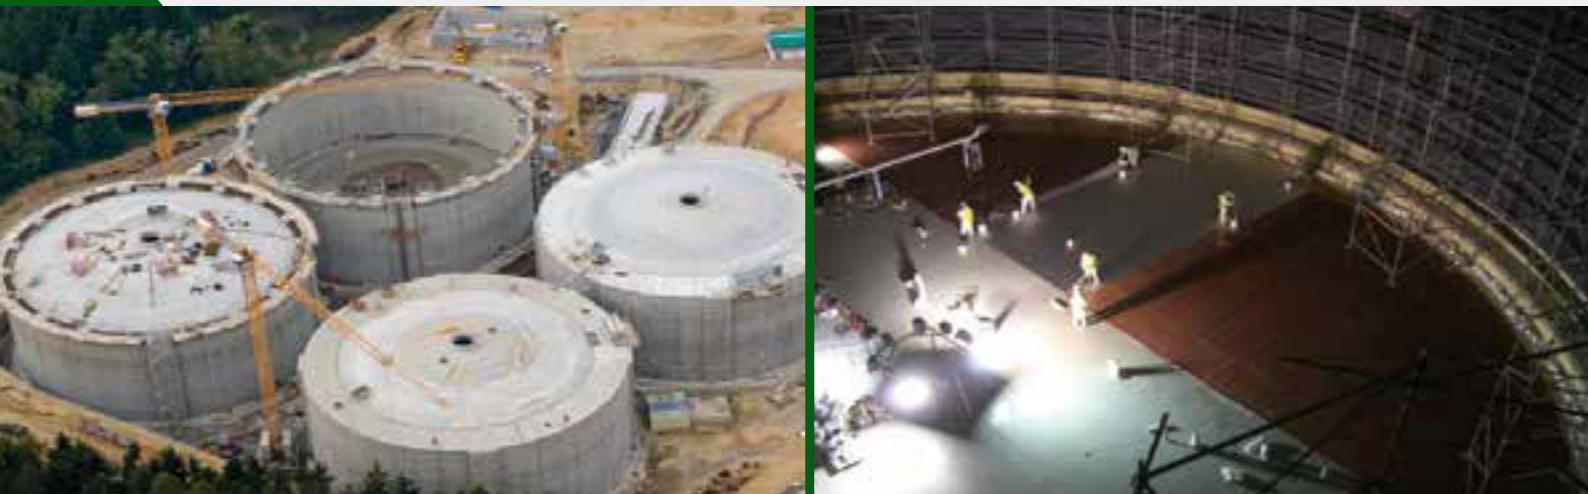
## Case Study 3: 2010 Czech Republic

Strategic fuel storage tank with total storage capacity of 1.8 mil. m<sup>3</sup>

Underground double wall concrete tank with a diameter of 48 m and a height of 22 m

Application of double-walled composite lining completed in 2011

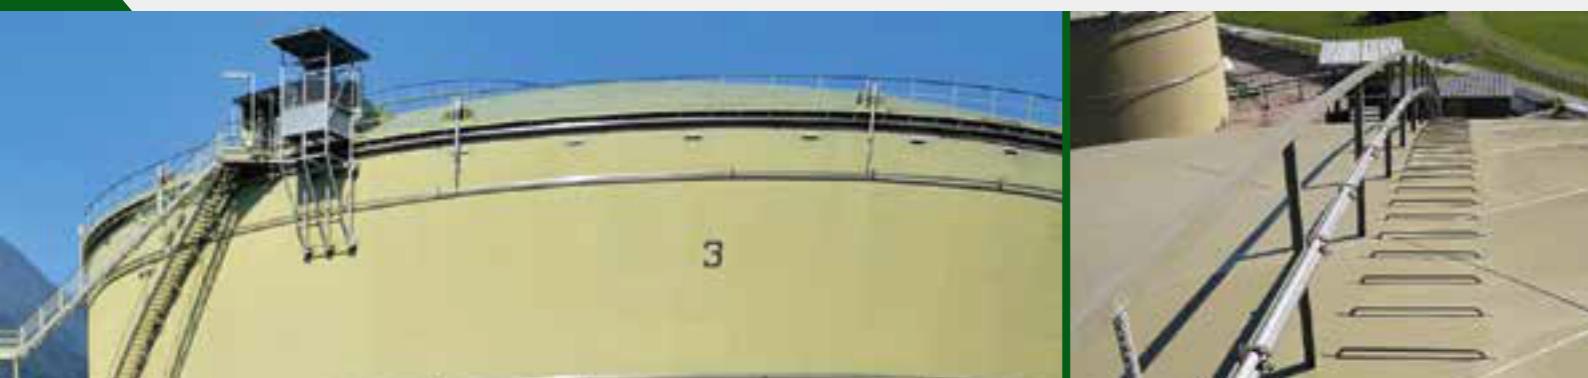
## Case Study 4: 2018 Austria

Tank roof lining for high corrosion (>C4) environment

Application of three different layers to sustain the C4 corrosion category: Ground-, Intermediate and Top layer

Executed with cleaning technology and material structures to reach 20 years of lifetime
